Luxembourg Airspace Infringements

An Air Safety bulletin is a document widely distributed by the DAC, whose aim is not to create any additional safety requirements but to inform all aviation stakeholders about a clearly identified risk and recommended actions, which are considered reasonably practicable for all involved actors.

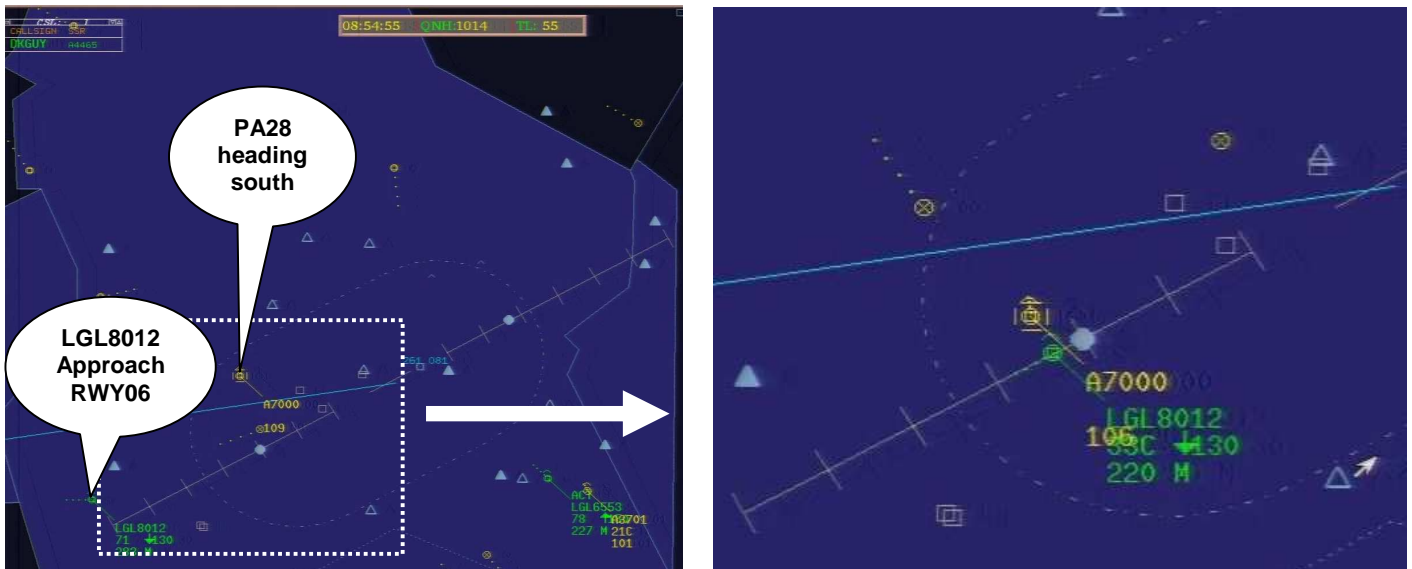
14/06/10 PA28 enters CTR at 2000 feet AMSL west of ALPHA without permission and proceeds southbound towards WLJ. Continuous calls from TWR, but the pilot reacts only after more than 2 minutes and turns around. PA28 almost reaches the extended centerline of runway 06, where IFR traffic is on final. Potential loss of separation.

ANA Radar records, 14/06/2010: CTR infringement by Piper PA28 (shown as A7000)

Situation at 8:54:55 UTC (left) and at 8:56:49 UTC (right, enlarged)

- 1 Pre-flight **Preparation** should be done properly with up-to-date maps, Notams and weather information
- 2 Accurate **Navigation** is essential in order to avoid airspace infringements. In case of doubt, a pilot can ask ATC to confirm his actual position.
- 3 **Communication** with controllers should be clear and done in due time.
