Luxembourg

Air Safety Bulletin

Number 16-001 - April 2016

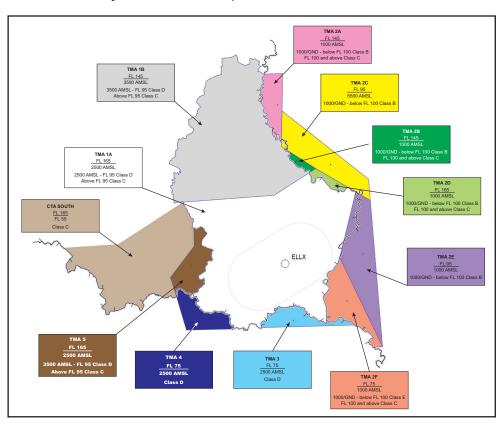
Airspace infringements occur when an aircraft enters notified airspace without previously requesting and obtaining clearance from the controlling authority of that airspace, or enters the airspace under conditions that were not contained in the clearance. Recent months have seen an increasing number of airspace infringements of the Luxembourg Terminal Control Area (TMA) or the Control Zone (CTR), most of them involving light aircraft on VFR flights or gliders. The picture to the

right shows the different parts of the Luxembourg TMA and CTR and their respective classes of airspace.

Ensuring that you follow the appropriate procedures, and in particular, obtaining a clearance before entering any airspace for which that is necessary, is essential for the safety of all airspace users. An

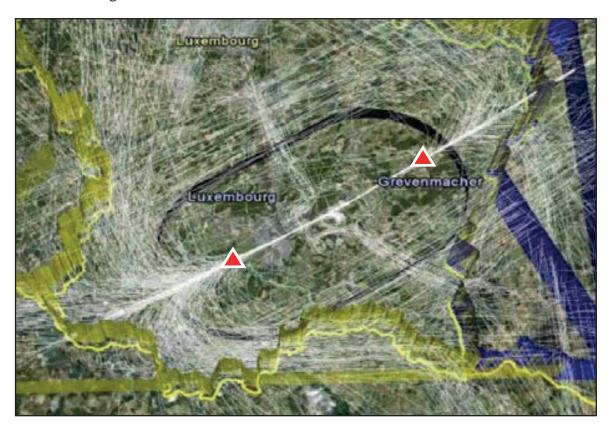
The picture below shows (in white lines) the trajectories of generally heavier aircraft taking off and landing at Luxembourg airport, and the red triangles represent the locations with the greatest risk of wake turbulence for lighter aircraft.

flying under VFR in the vicinity of Luxembourg airspace maintain a good look out and manoeuvre to avoid the risks of triggering a TCAS RA or a wake turbulence encounter.

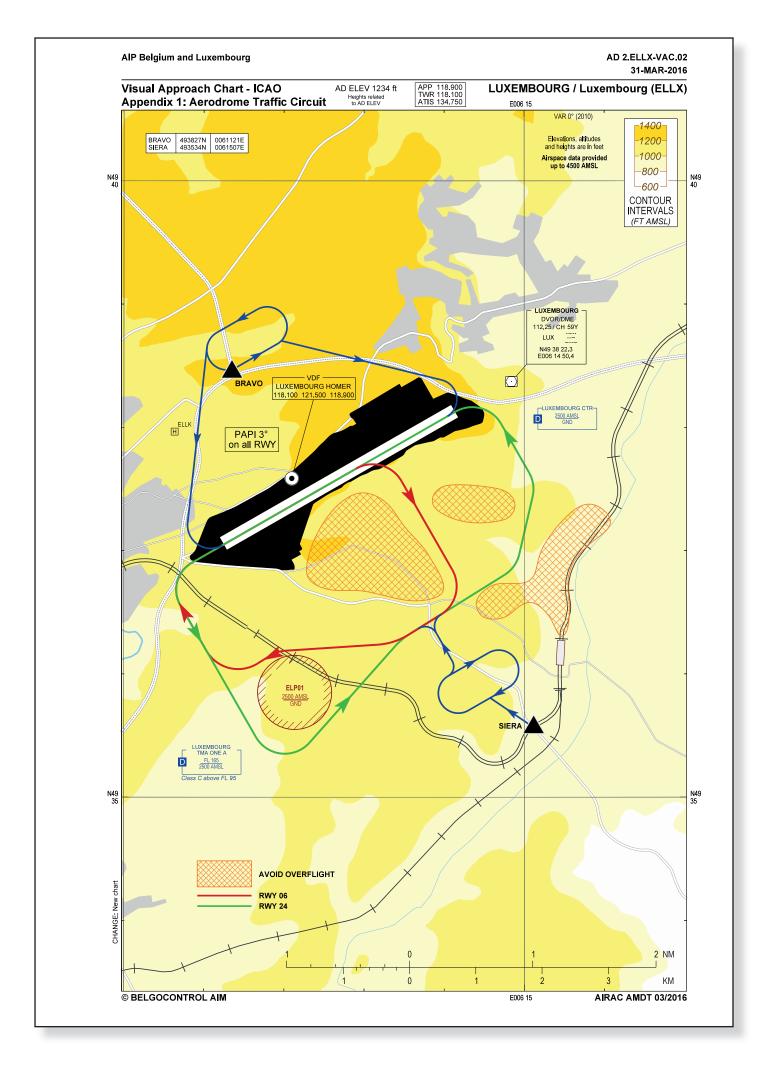
The visual traffic pattern for runway 24 now follows a path to the south and west of prohibited area ELPo1 in the turn from crosswind to downwind legs. This change has been introduced in order to reduce the noise nuisance caused to the airport's neighbours. (The visual traffic pattern for runway o6 is unchanged).
